Existing Deficiencies

I-69 SPUR, I-66/I-65 SPUR
AND US 60

Butler, Daviess, Henderson
Ohio, and Warren Counties
Kentucky

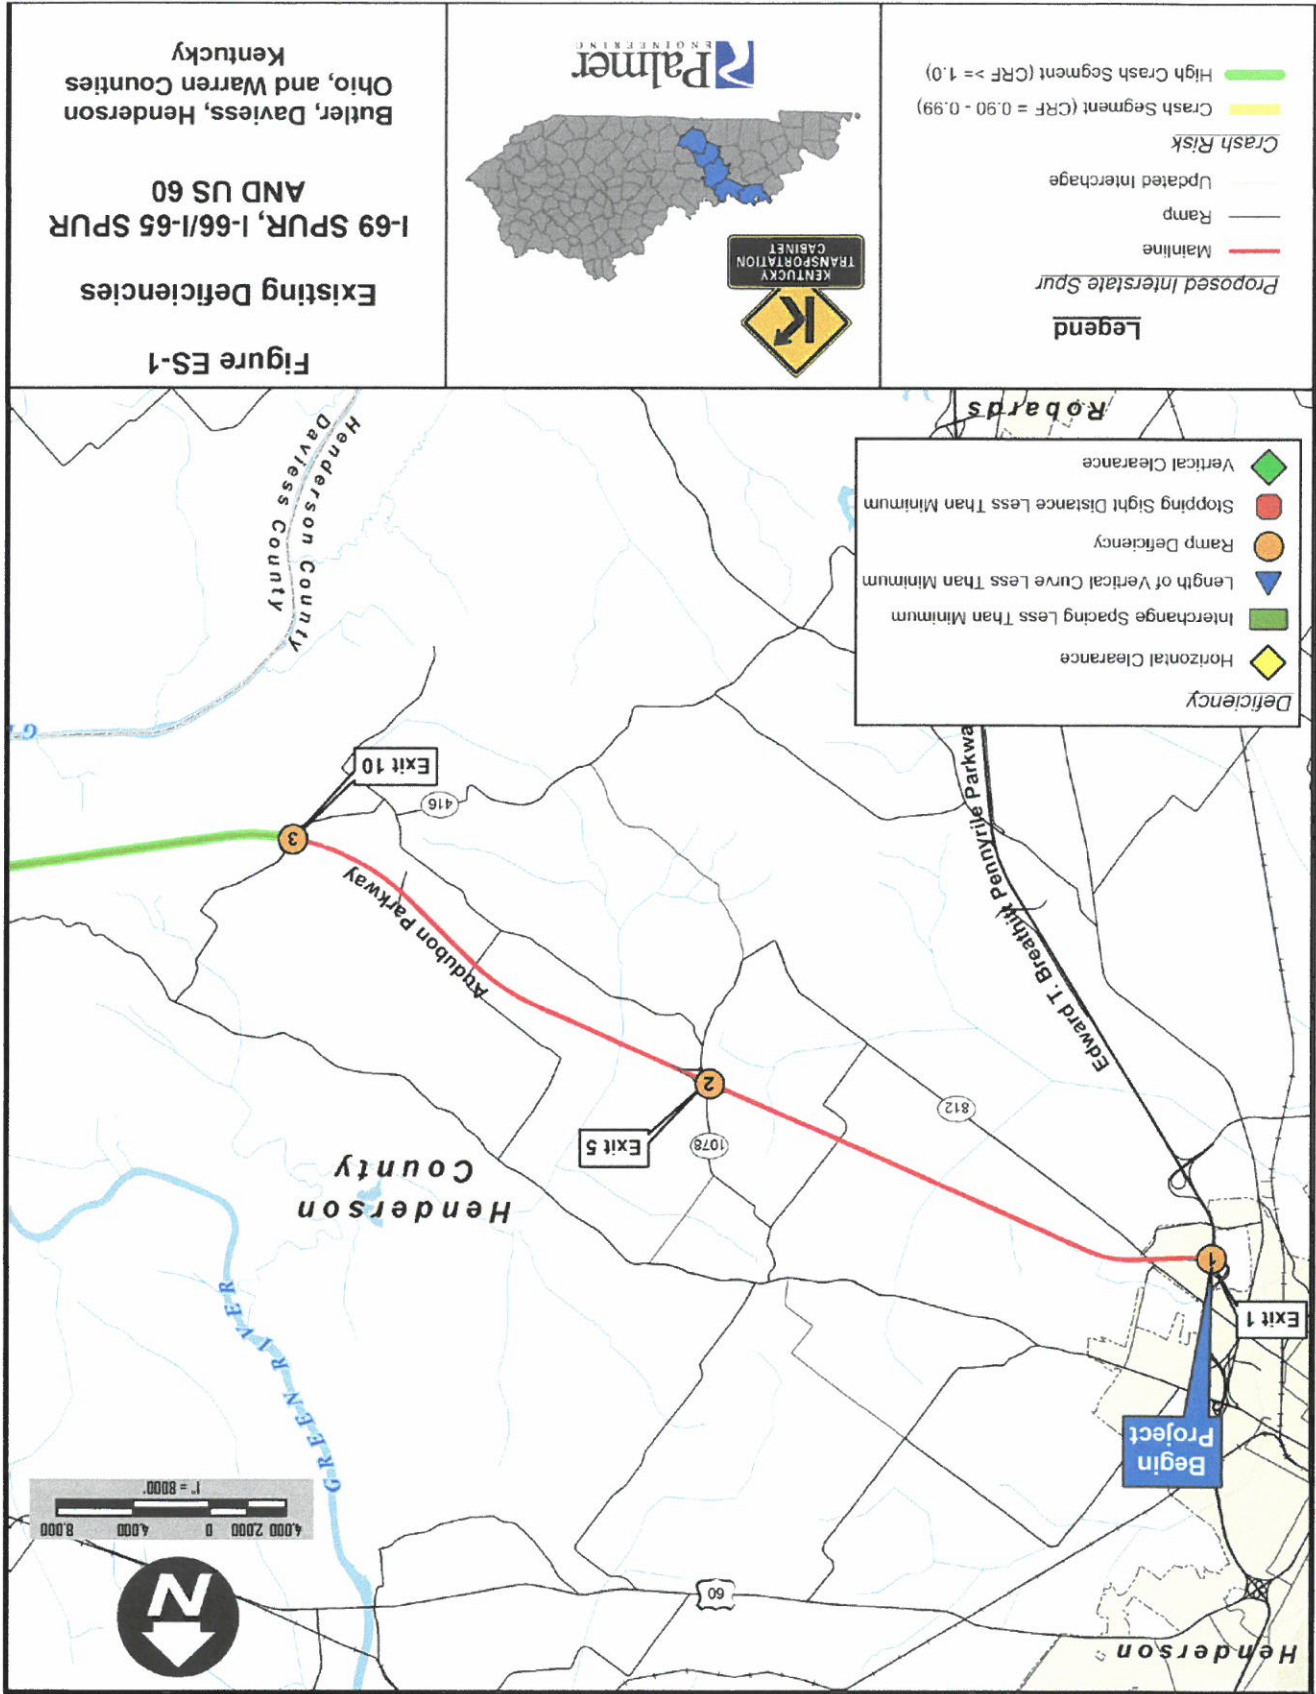
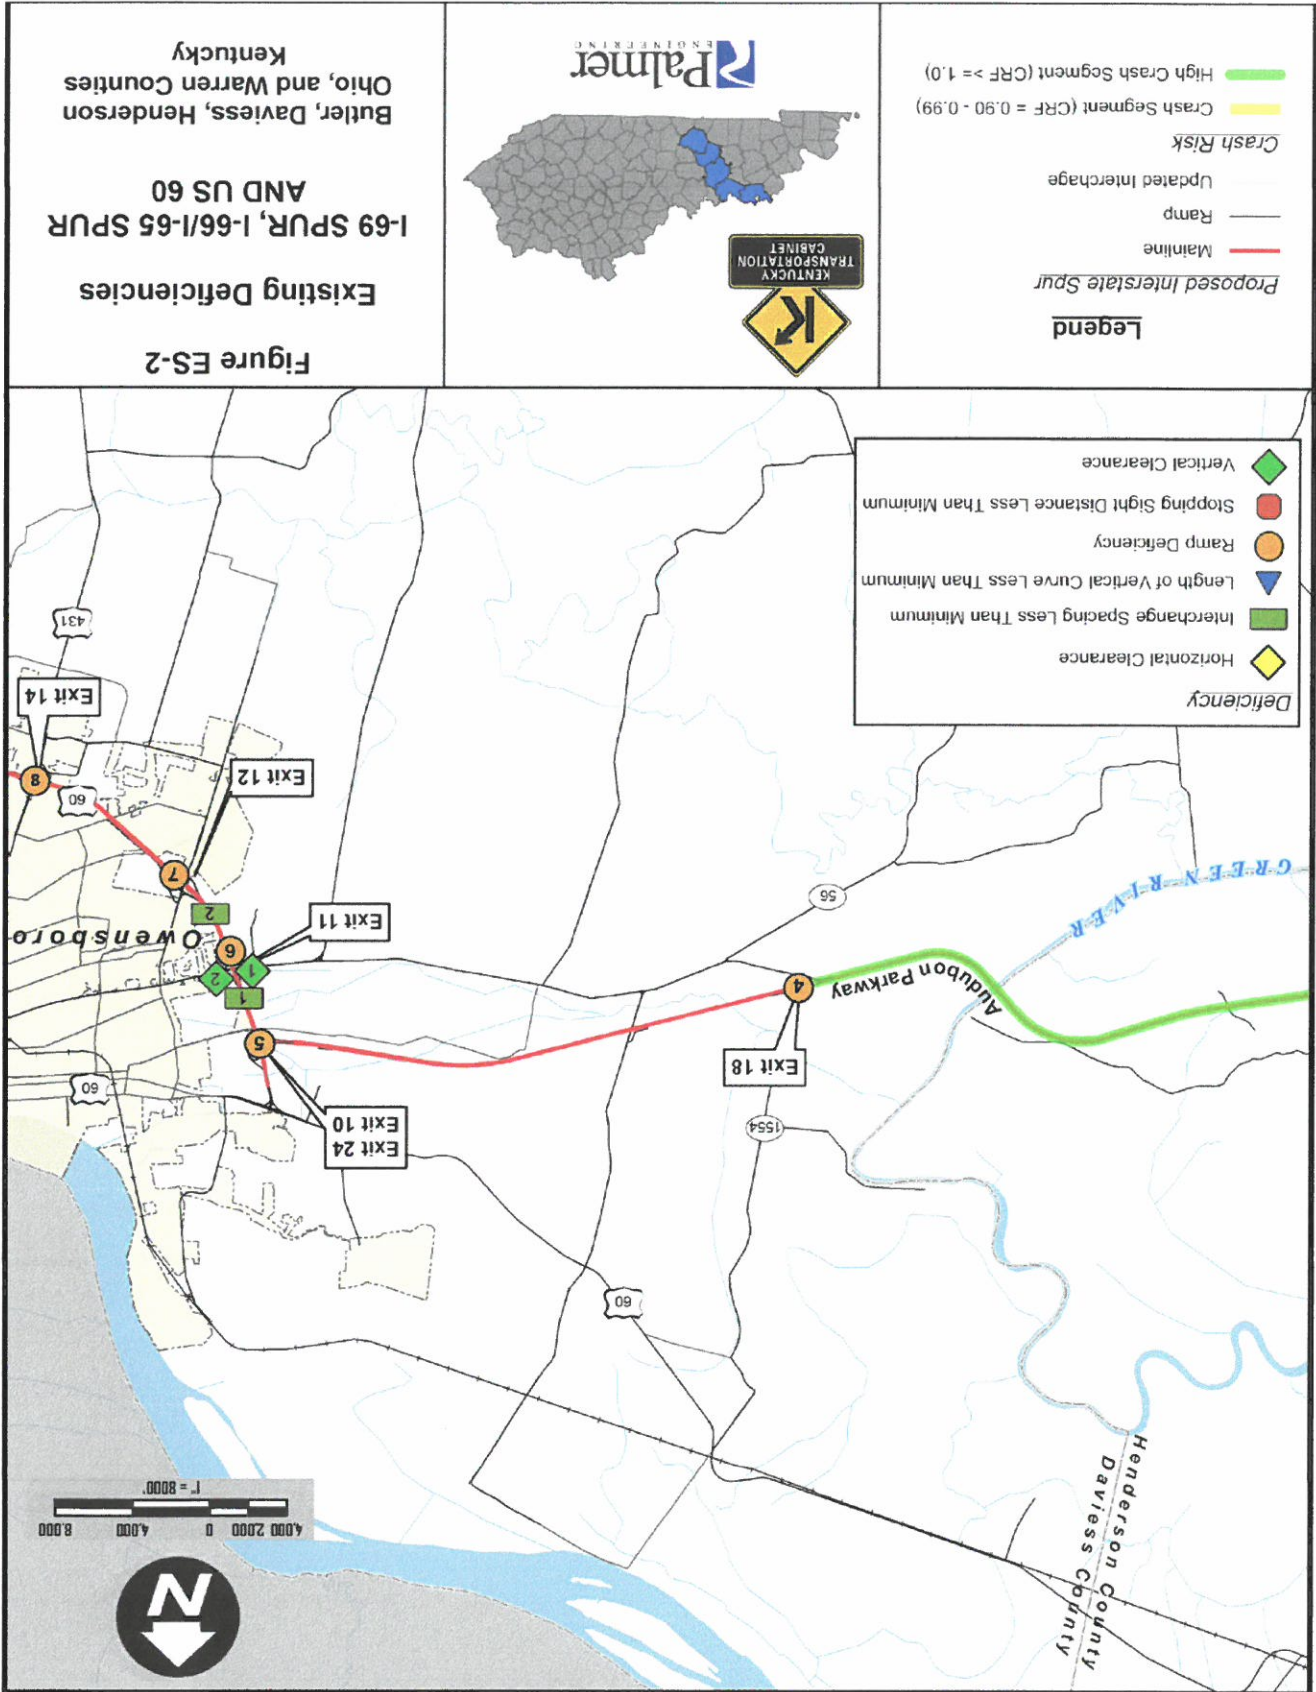
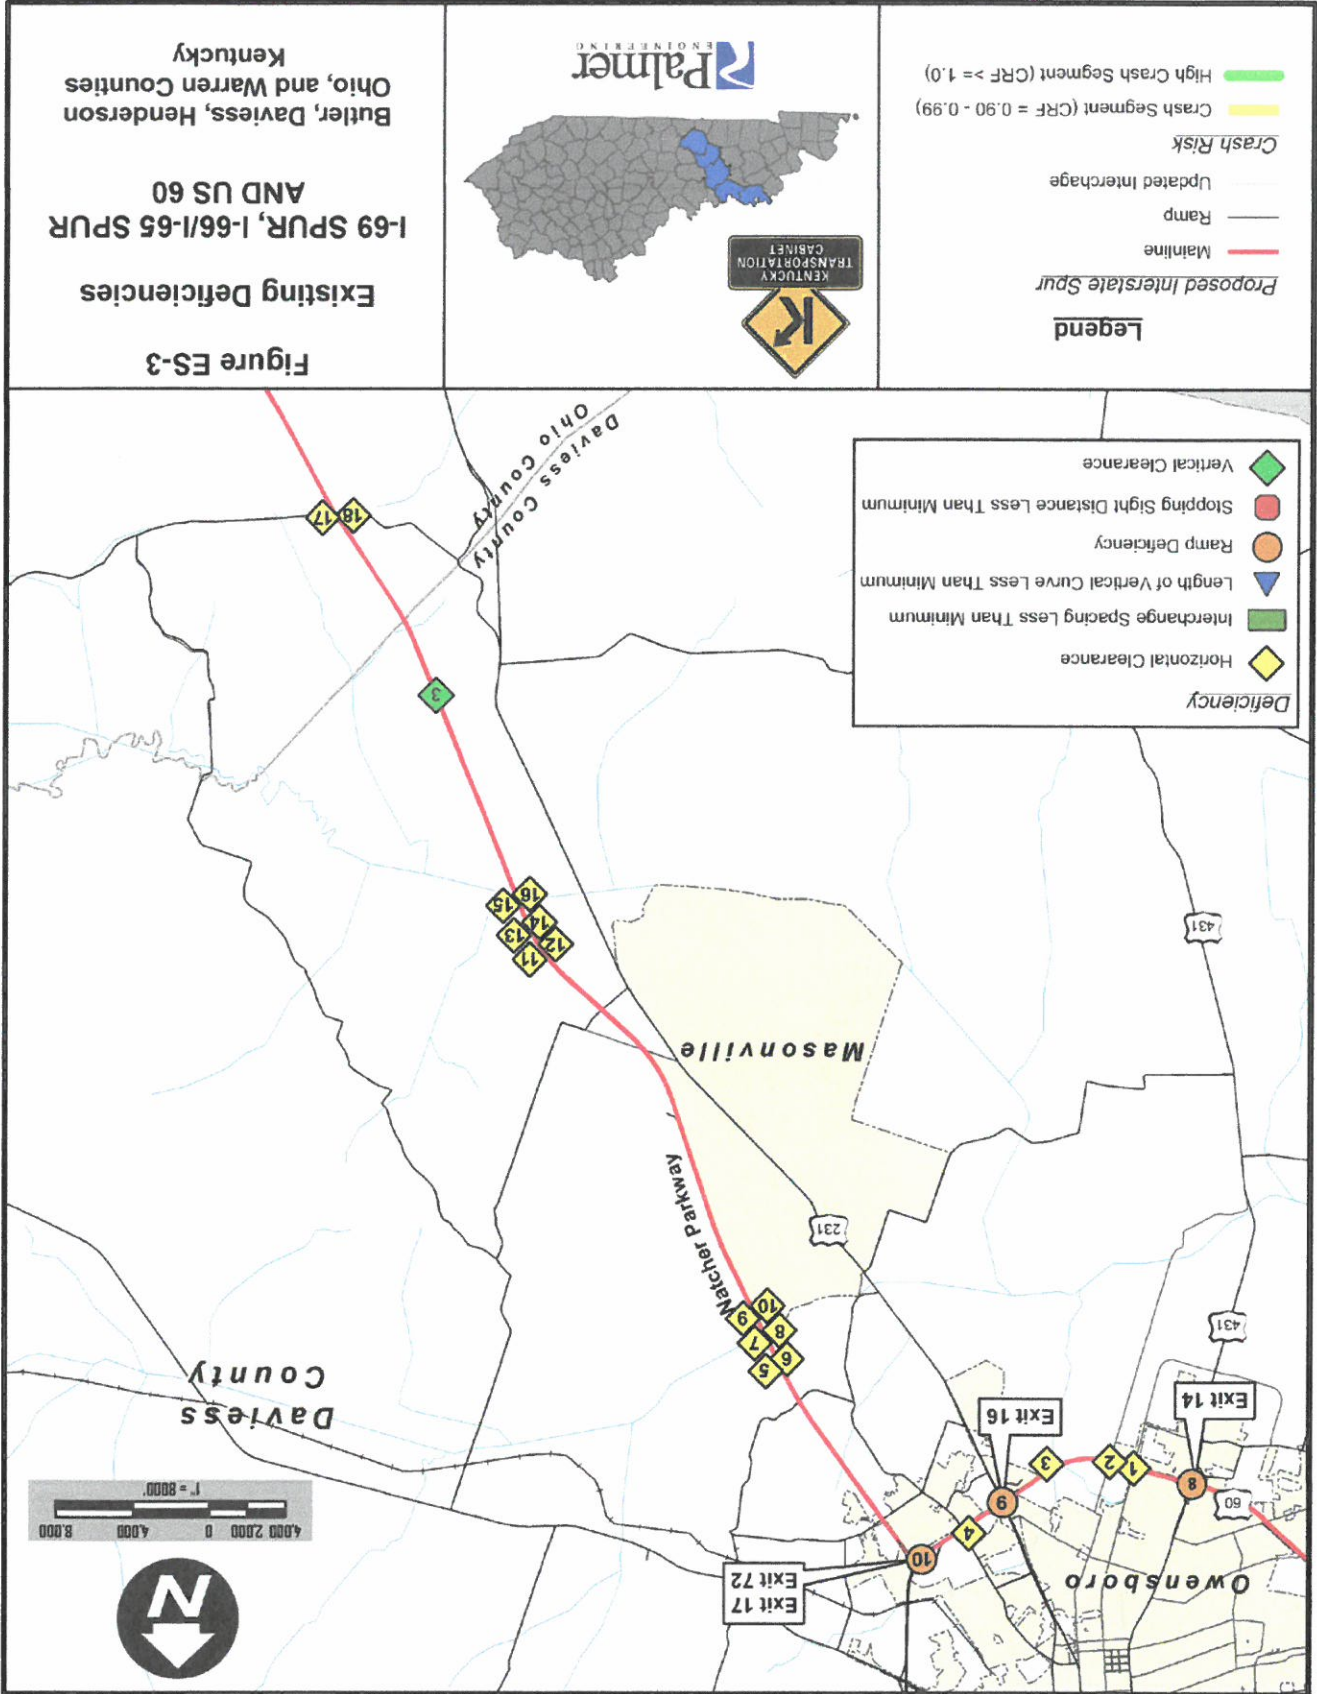
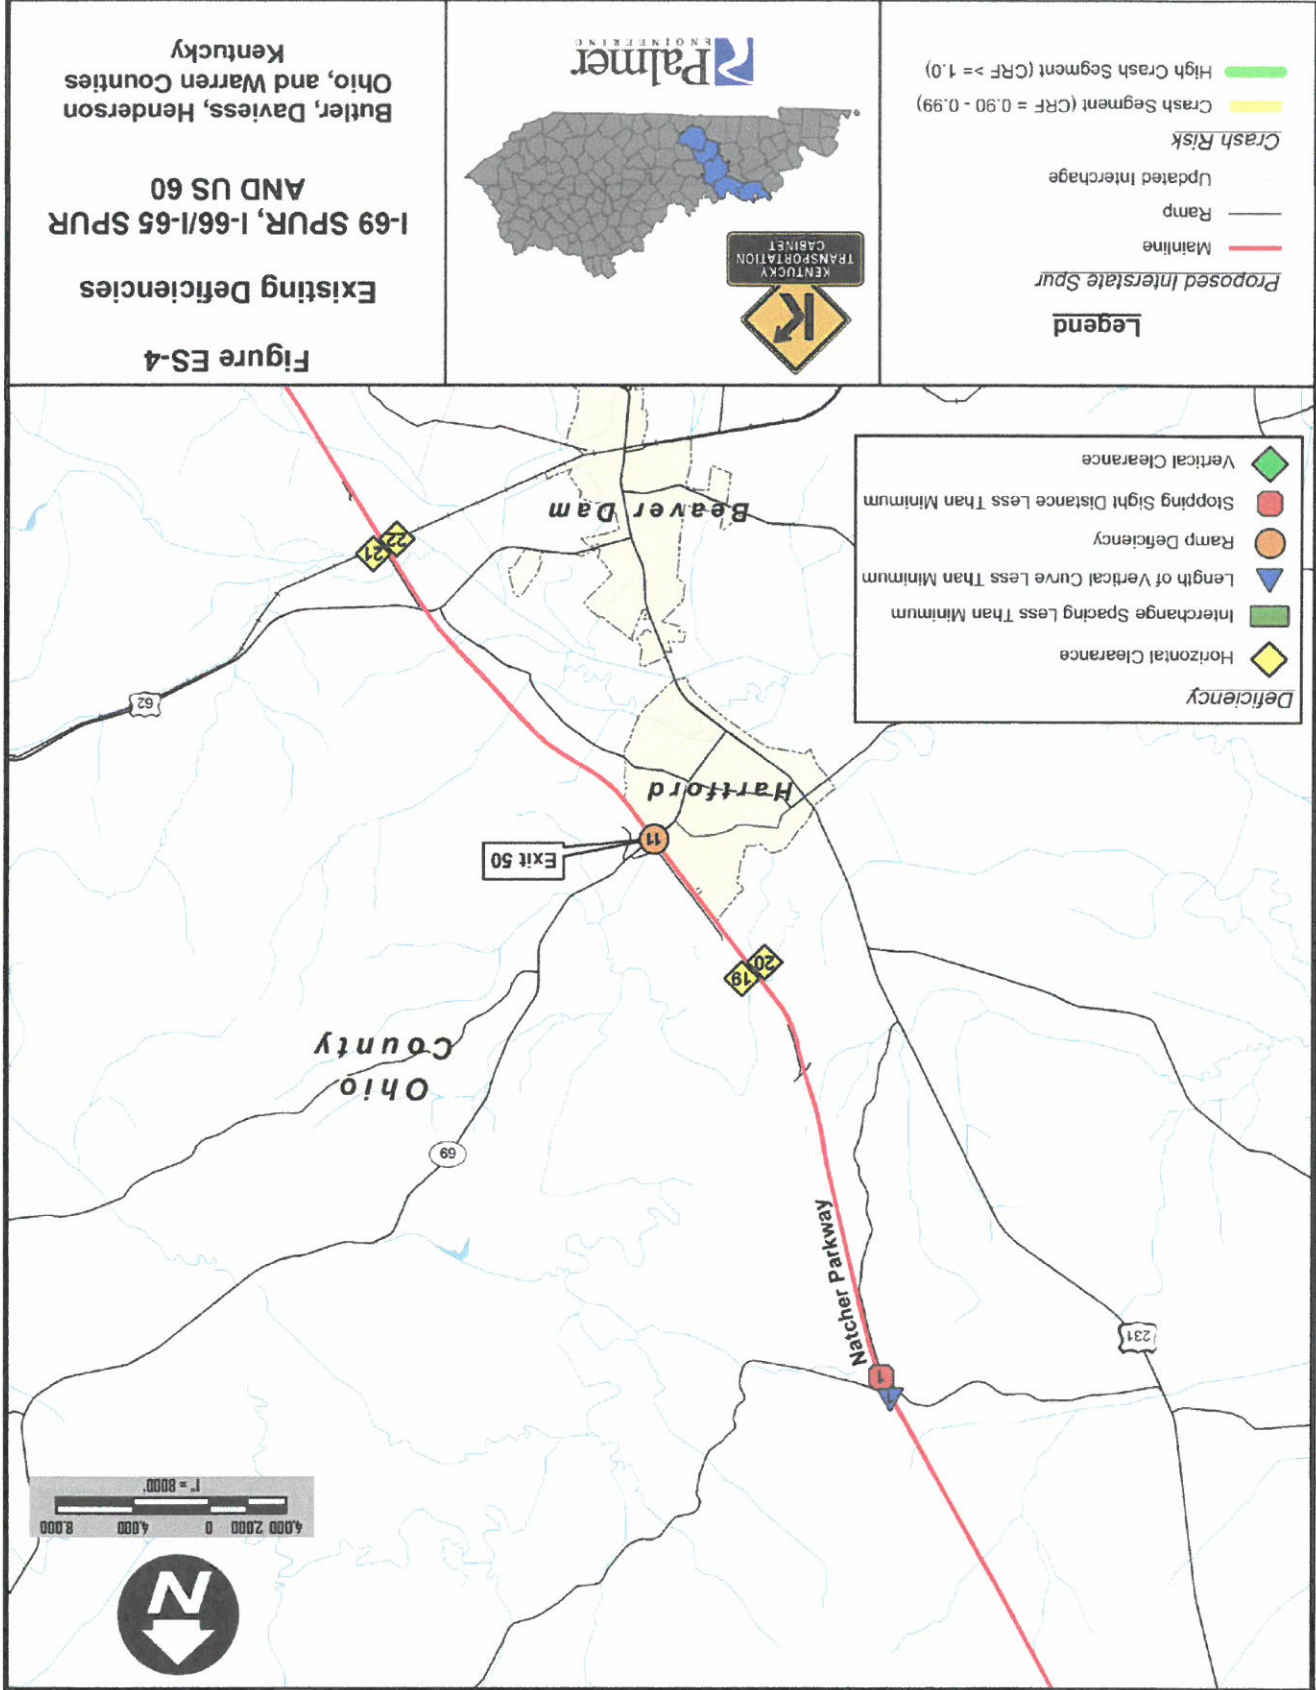
Figure ES-4

- Proposed Interstate Spur
- Mainline
- Ramp
- Updated Interchange
- Crash Risk
 - High Crash Segment (CRF >= 1.0)
 - Crash Segment (CRF = 0.90 - 0.99)

- Deficiency
 - Horizontal Clearance
 - Interchange Spacing Less Than Minimum
 - Length of Vertical Curve Less Than Minimum
 - Ramp Deficiency
 - Stopping Sight Distance Less Than Minimum
 - Vertical Clearance
